VOLVO OCEAN RACE INDEPENDENT REPORT INTO THE STRANDING OF VESTAS WIND

The Vestas Wind Report (Version 1.2)

An Independent Report that was convened by the Volvo Ocean Race following the stranding of the yacht Vestas Wind on 29 November 2014 on the Cargados Carajos Shoals 240 nm north east of Mauritius while competing in the 2014 – 2015 Volvo Ocean Race round the world.

31 January 2015

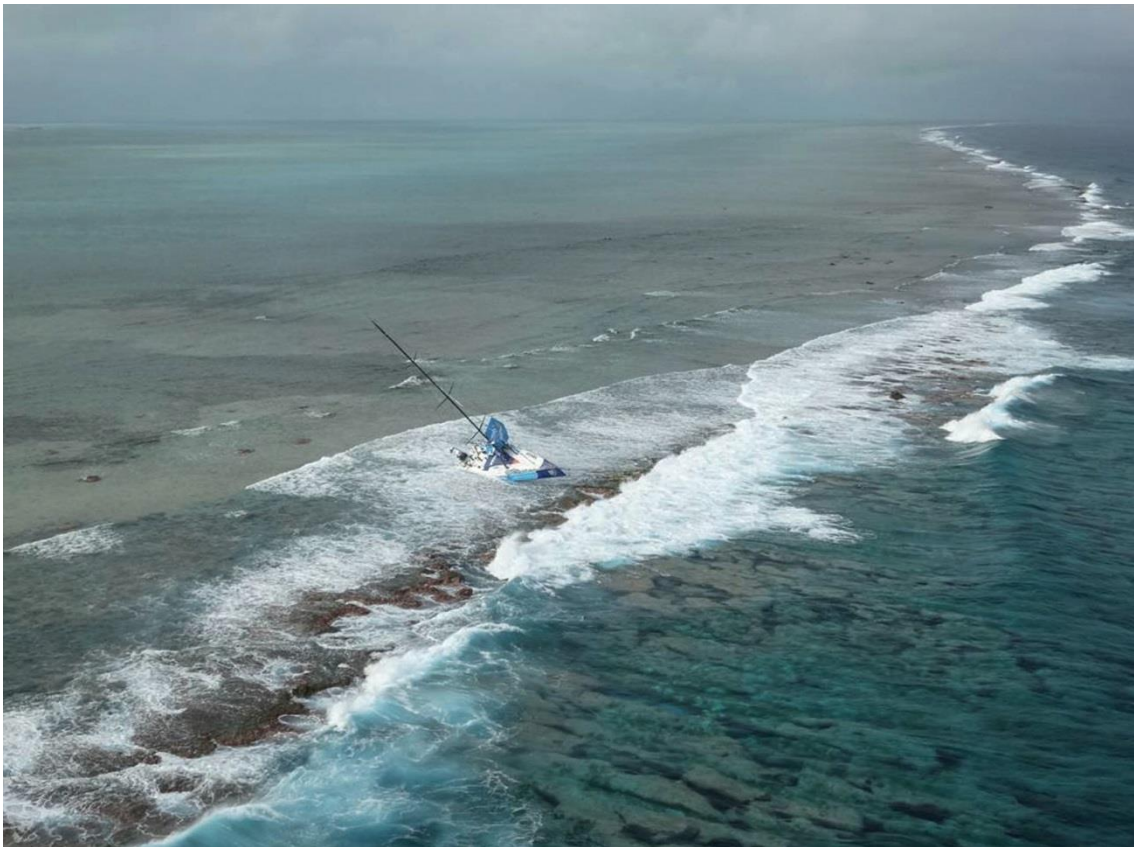
81. When the boat had settled on a southeast heading and pointing to sea it would appear that the bulb was constrained in one of the gutters. The boat maintained its heading but was being pushed back towards the reef face. The hull was to starboard of the keel and heeled to starboard. With the boat now on the starboard tack, the keel was on the wrong side and the pressure from the sails was driving the keel harder on to the seabed and effectively jamming the boat on to the reef. By this stage the rudders had gone – broken off after striking the bottom when the boat pirouetted around the keel bulb.

Figure 5 – The day after from the air – showing where the boat ended up, the reef face ahead of it with the breaking waves and the gutters in the seabed bottom where the keel was caught
Credit: National Coast Guard of Mauritius

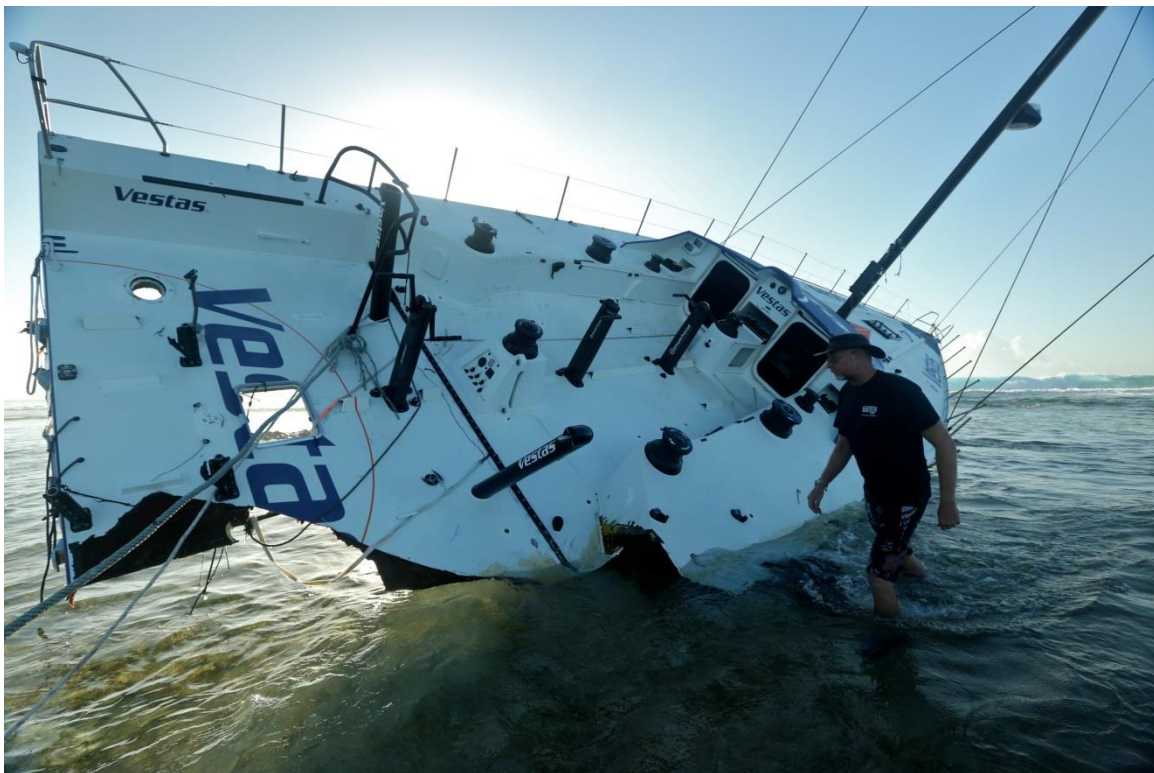
94. The stern of the boat was being destroyed (Figure 6) and there was concern that the second liferaft could be lost if it was not released. A lot of gear from the aft watertight compartment, including the anchors and emergency water supplies had already been lost when the compartment was opened to the sea. The spare first aid stores had also been lost from the emergency locker which is forward of the aft watertight compartment, when the bottom of the boat was damaged in that area.

Figure 6 – A telling shot of the damage sustained to the starboard quarter
Credit: Shane Smart/ Volvo Ocean Race

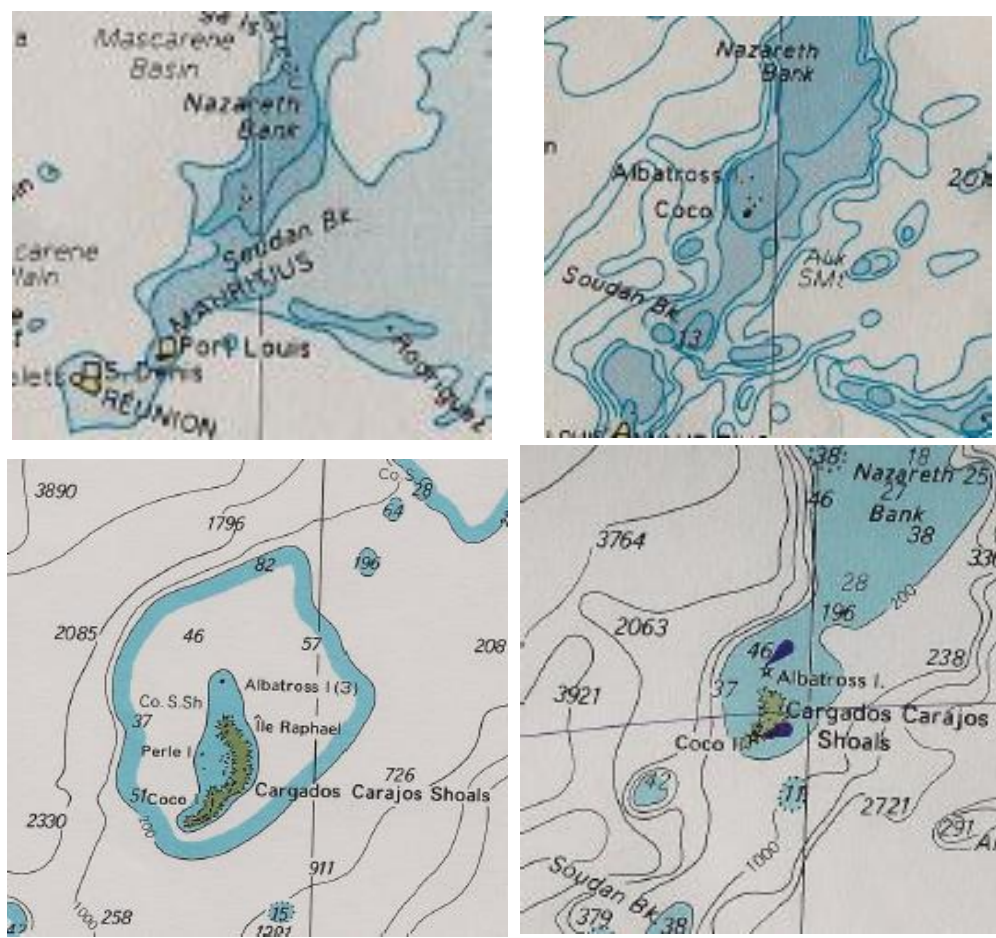
Figure 8 – A collage of official paper chart presentations of the Cargados Carajos Shoals – From top left hand corner clockwise 1:45 Million (UKHO 4000); 1:20M (UKHO 4005); 1:10M (UKHO 4070); 1:3.5M (UKHO 4702)

138. The true position and charting of the reef did not contribute to the grounding of *Vestas Wind*. Although the Cargados Carajos Shoals are well surveyed, the general area and caution on the C-Map product should have required referral to the paper charts and Sailing Directions. The paper charts would not have to be used for plotting and laying out tracks in order to have helped the crew avoid the grounding. They would simply need to have been viewed to identify dangers in the vicinity of prospective tracks. On paper charts of every scale that cover the area the hazard was clear (Figure 8).

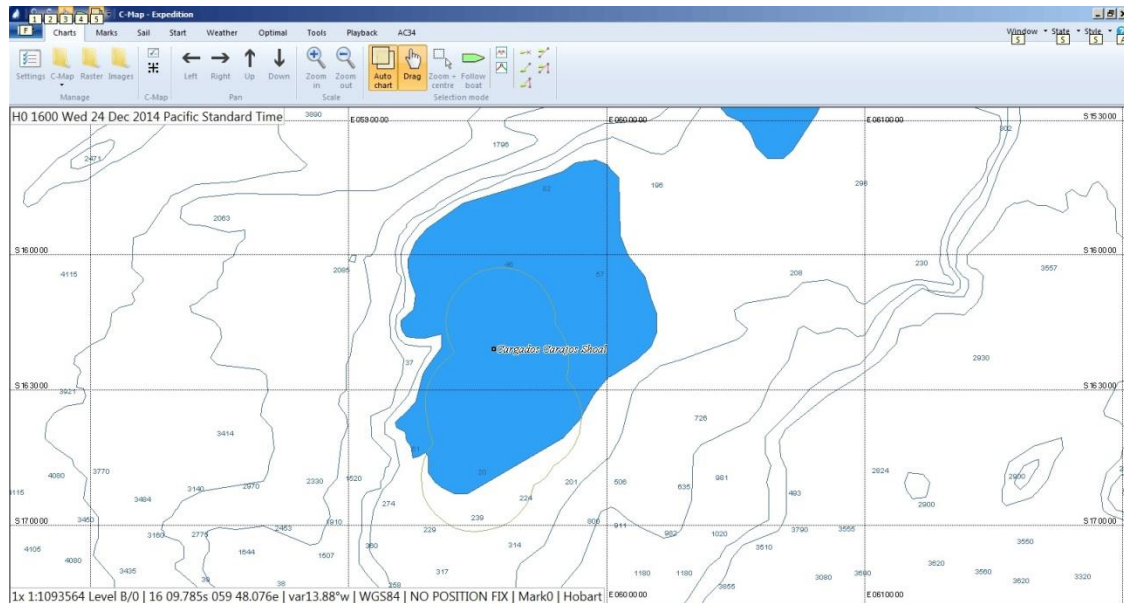
displayed on Expedition (Figure 9) using the world map chart, the minimum depth was about 40m. He did not have detailed charts installed on his personal computer and so could not see either the reef or that the 'chart bounds'¹¹ feature to indicate large scale cartography was available for Cargados Carajos Shoals.

Figure 9 — World Map Coverage in C-Map of Cargados Carajos Shoals – what was presented on Adrena and Expedition without the detailed C-Map dongle – the presentation the navigator had on his personal computer

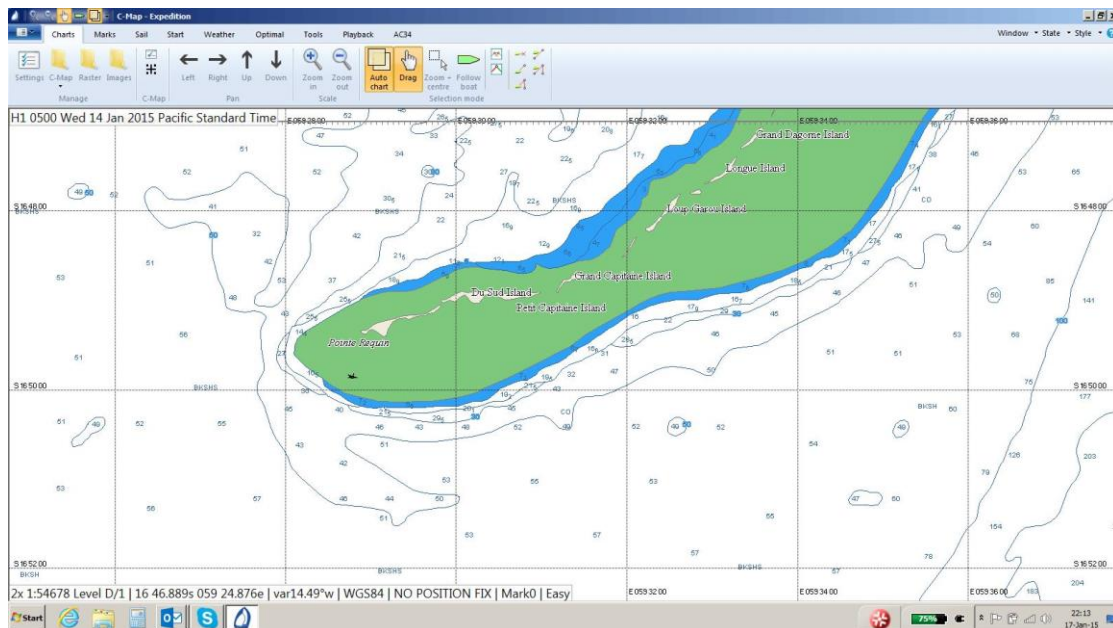
146. The navigator stated that he used the 'chart bounds' display feature on the Expedition system as there were not many charts along the route and they did not clutter the screen. This is confirmed by photos taken onboard the boat shortly after the grounding. This feature is known to experienced navigators as a trigger that a larger scale chart is available and there are potential dangers worth investigating. Unfortunately this did not alert the navigator to the fact that there was large scale detailed chart data available covering the Cargados Carajos Shoals and he did not zoom in and so gain access to the large scale chart of the dangers.

Figure 10 – Part of the large scale chart available at Level D/1 on Expedition/C-Map – but was not available without the detailed charts installed

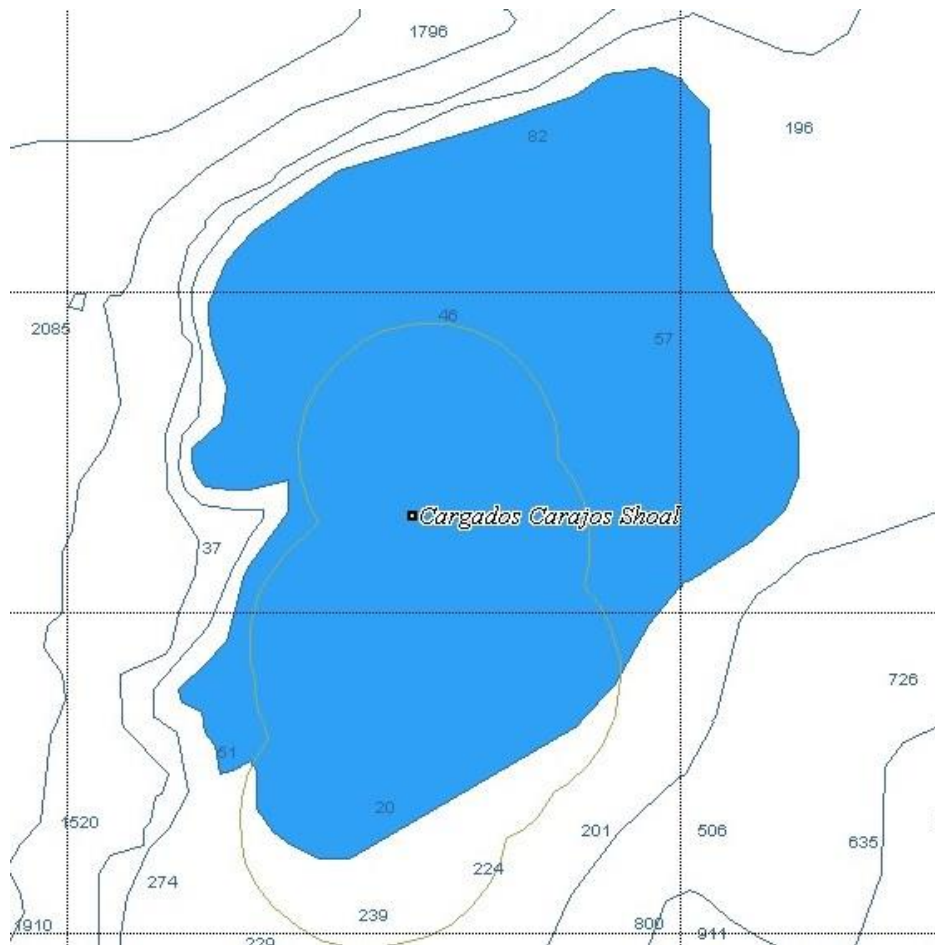
Figure 11 – A magnification of World Map Coverage in C-Map of Cargados Carajos Shoals that was embedded in the Expedition and Adrena systems

149. Figure 11 shows the C-Map Max chart as displayed on Expedition at about the 1:1.09M scale, on the World Map Coverage without the detailed C-Map dogle. The same presentation is available at Zoom Level B/0 with the detailed dogle and has the option of enabling 'chart bounds'. Close examination reveals five charted spot depths at the Cargados Carajos Shoals. Clockwise from the south, they are 20m, 51m, 46m, 82m and 57m. The faint circles are the arcs marking a cautionary area that defines the Territorial Seas surrounding the Mauritian Islands that are part of the shoals. These arcs provide a clue of the navigational danger in that they are based on a land boundary but they are faint and easily missed and can be confused with the depth contour lines.

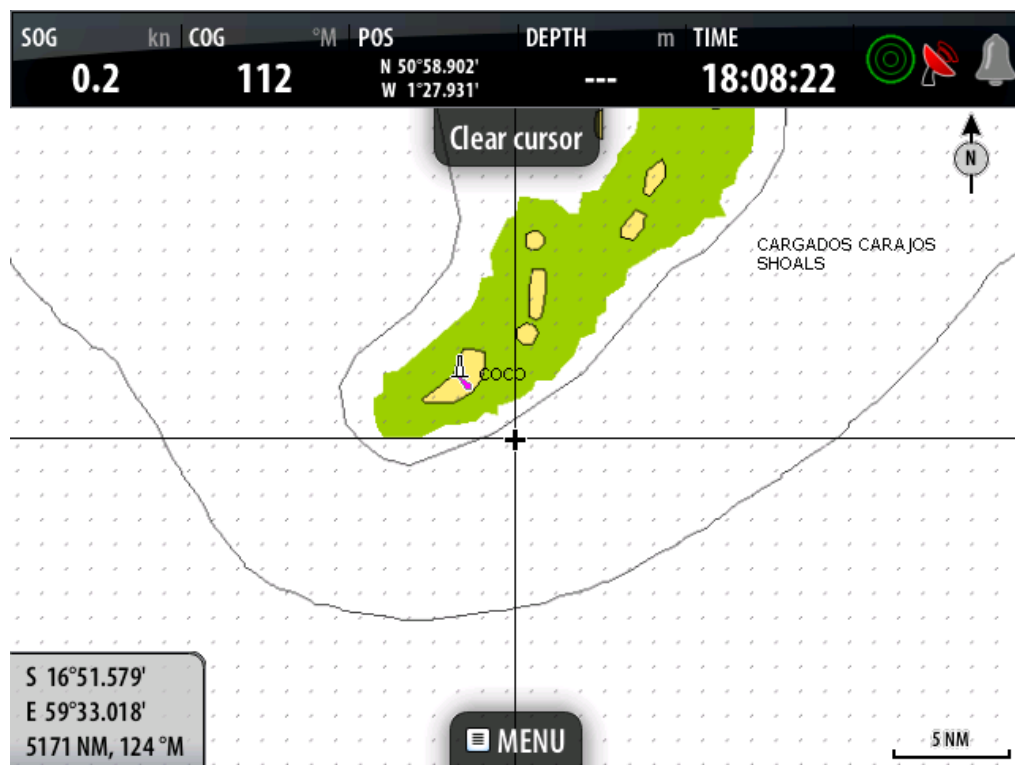
155. The main use of the MFD was for AIS in shipping lanes and also to monitor other race yachts when in range. The typical AIS range was about 12nm and the MFD would be set at a range where all AIS contacts would be seen at 15nm. This means that if the MFD was set to display the chartplotter, possibly with AIS and radar overlays, it could have provided 45 minutes to an hour's warning of the reef being on the track ahead. This would have to be observed to be of any use; but was not. Radar was not in use: there was no shipping in the area and no other yachts in AIS range. The 'tunnel' MFD could have last been used to switch on the navigation lights and remained on that page. The navigation station was unattended and even though the reef was possibly being displayed it was unobserved.

Figure 13 – Screenshot from the B&G Zeus 7 MFD – Showing the base chart presentation of the Cargados Carajos Shoals – scale bottom right hand corner

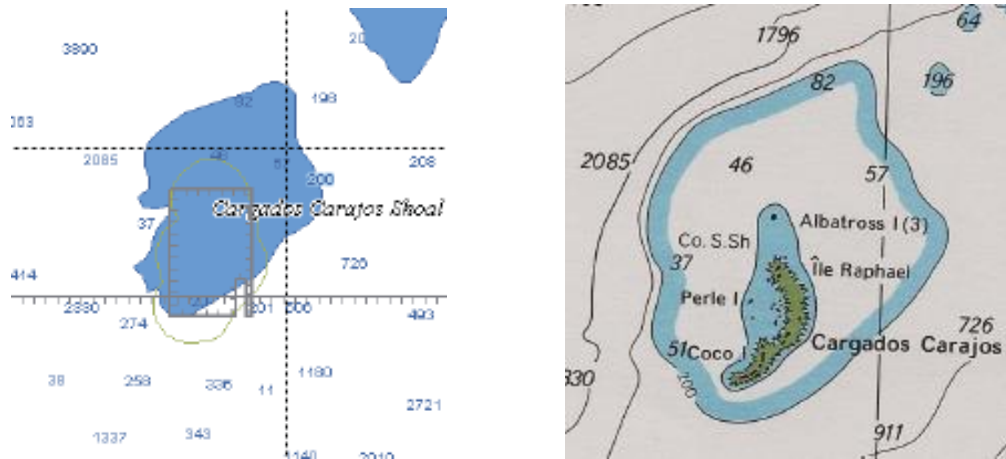
192. This is no minor omission. It is not a small isolated danger. The north to south extent of the dangers and off-lying islands, between Albatross Island in the north and Coco Island in the south is about 36nm. The east to west spread is about 15nm creating a total area of over 500nm². The length of the eastern side of the reef edge is more than 35nm. The Cargados Carajos Shoals have been well known to mariners for many years and appear on charts dating back to the 17th Century.

Figure 15 – A comparison between the detail shown on Expedition/C-Map Level A/O 1:3.3 million and UKHO Chart 4702 Chagos to Madagascar 1: 3.5 million

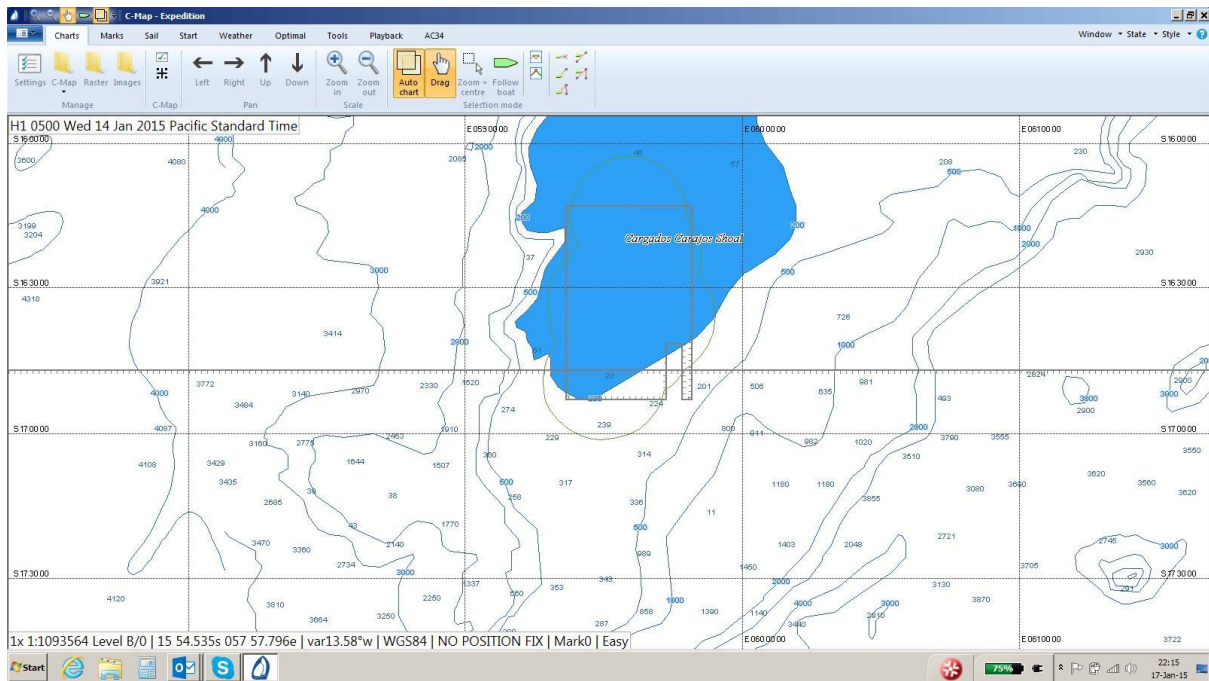
195. A peculiarity of Expedition is that to obtain the detail available from the larger scale chart the user has to zoom in within the area marked by the chart bounds. For example, if a user zoomed in to the north of the shoals, outside the chart bounds, in the vicinity of the 46m sounding (Figure 16) to the highest level of detail (Level D/4), she or he would not access any more detail as it is not available. However if the navigator, at Level D, panned to the south so that the display was in the area marked by the chart bounds they would still not access additional data even though it was available. The user will only obtain the larger scale chart if they position the display within the chart bounds area at a smaller level (A-C) and then zoom in to Level D.

Figure 16 – Expedition/C-Map presentation of Cargados Carajos Shoals at Level B/0 (1:1.1million) Displaying the 'Chart Bounds' of the reef and dangers and the 'Cautionary Areas' marking the Territorial Sea
