VOLVO OCEAN RACE INDEPENDENT REPORT INTO THE STRANDING OF VESTAS WIND

The Vestas Wind Report (Version 1.2)

An Independent Report that was convened by the Volvo Ocean Race following the stranding of the yacht Vestas Wind on 29 November 2014 on the Cargados Carajos Shoals 240 nm north east of Mauritius while competing in the 2014 – 2015 Volvo Ocean Race round the world.

31 January 2015

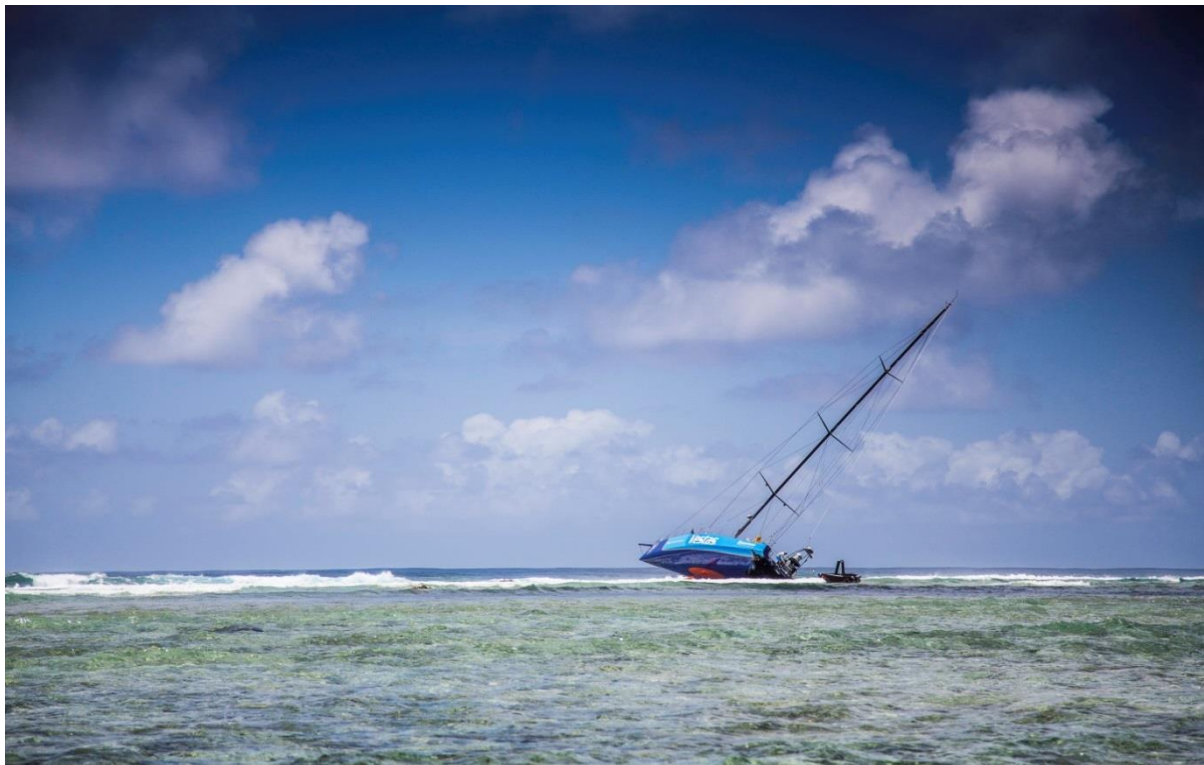
Figure 7 – *Vestas Wind* the day following the grounding with the crew starting the retrieval operation
Credit: Brian Carlin/Team Vestas Wind/Volvo Ocean Race

103. *Vestas Wind* was itself lifted over the reef's edge and onto the reef shortly after the crew left the boat – possibly about 0400 – and came to rest in the well photographed position at Figure 7. The next day the crew were amazed by where the boat had moved to from where it was abandoned.

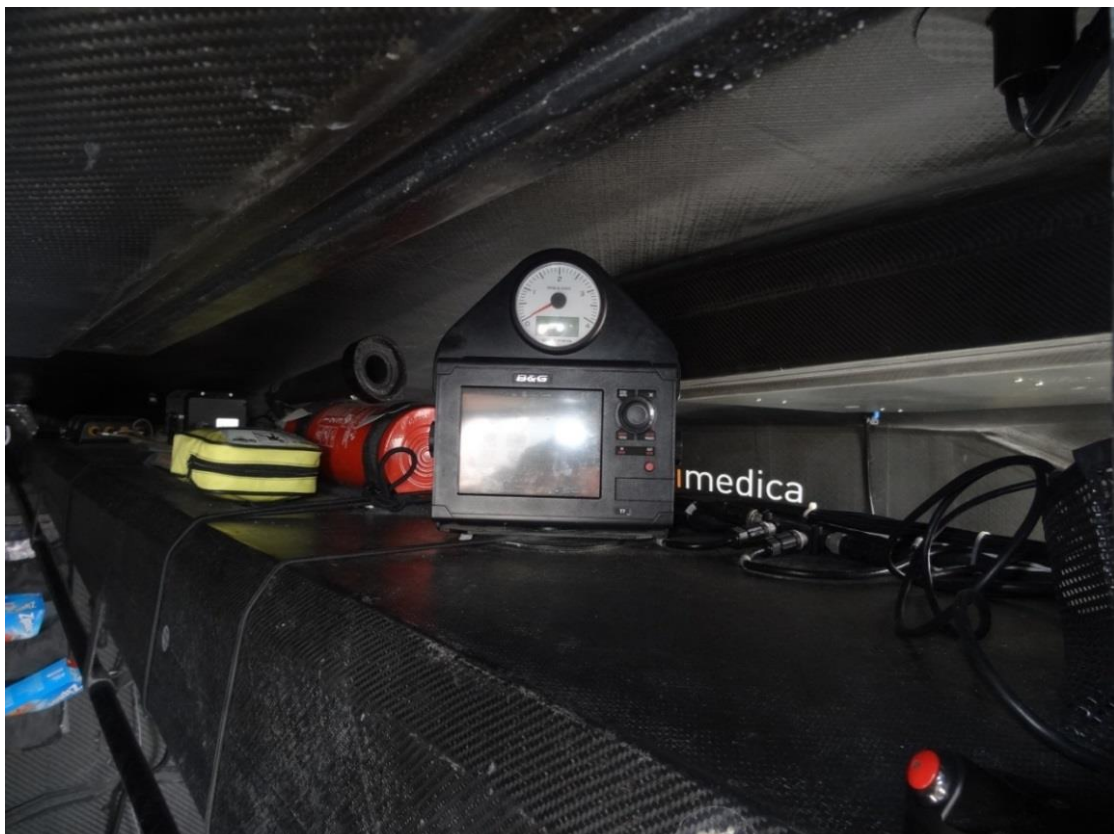
Figure 12 - Photo of the 'tunnel' MFD just inside the cabin available to crew on deck
Credit: Photo by Chuck Hawley

154. The chartplotter default world-coverage map does include a depiction of the Cargados Carajos Shoals. When the navigator awoke after the grounding he went to the nav station and could clearly see the reef on the MFD and the boat next to it. This was possibly his first indication of what had happened.

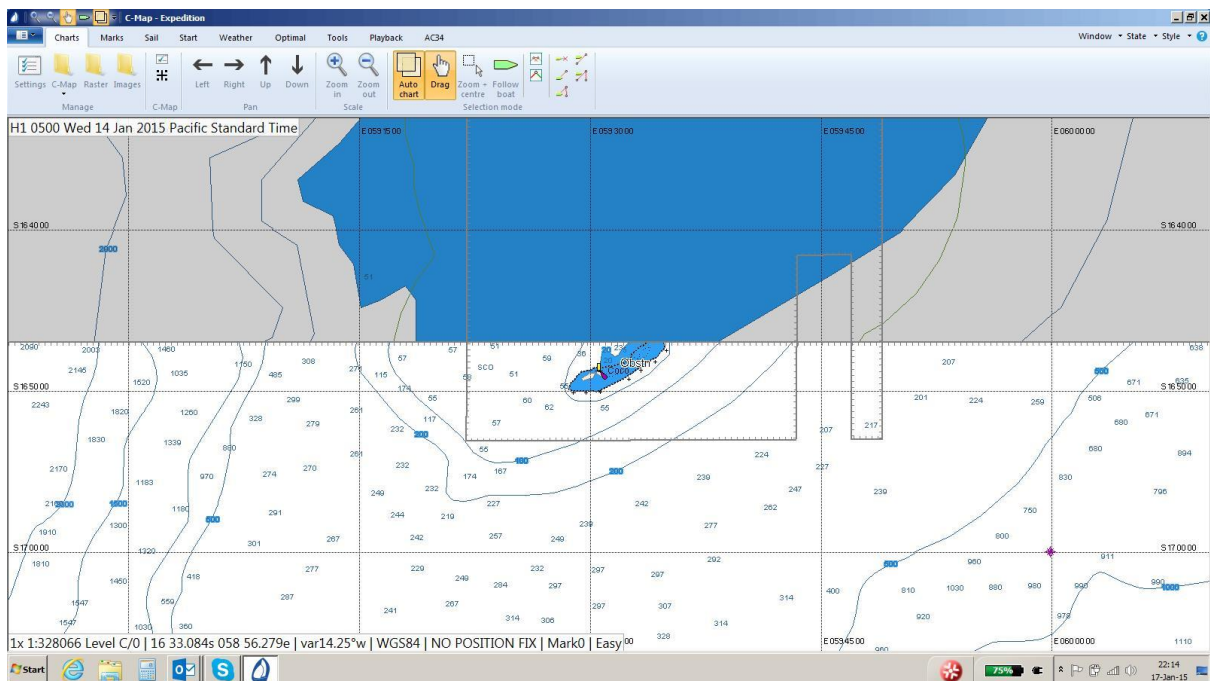
Figure 14 – Southern tip of Cargados Carajos Shoals – showing the chart by chart display on C-Map/Expedition at Level C/0 Scale1: 328,066 and displaying a small segment of the larger scale chart

was shown at Level C on C-Map (Figure 14), but it was removed by a small correction¹⁴ to the larger scale charts of the area in 2012.

- chart bounds outlining the Cargados Carajos Shoals reef,
- the name Cargados Carajos Shoals is shown providing an alert to shallow water,
- the economic boundaries are shown, although when using the default colour pallet, they are difficult to see against the blue 200m depth area and can also be confused with depth contour lines, and
- at one location to the south of the shoals, a small piece of a larger scale chart can be seen at Zoom Level C (Figure 14).

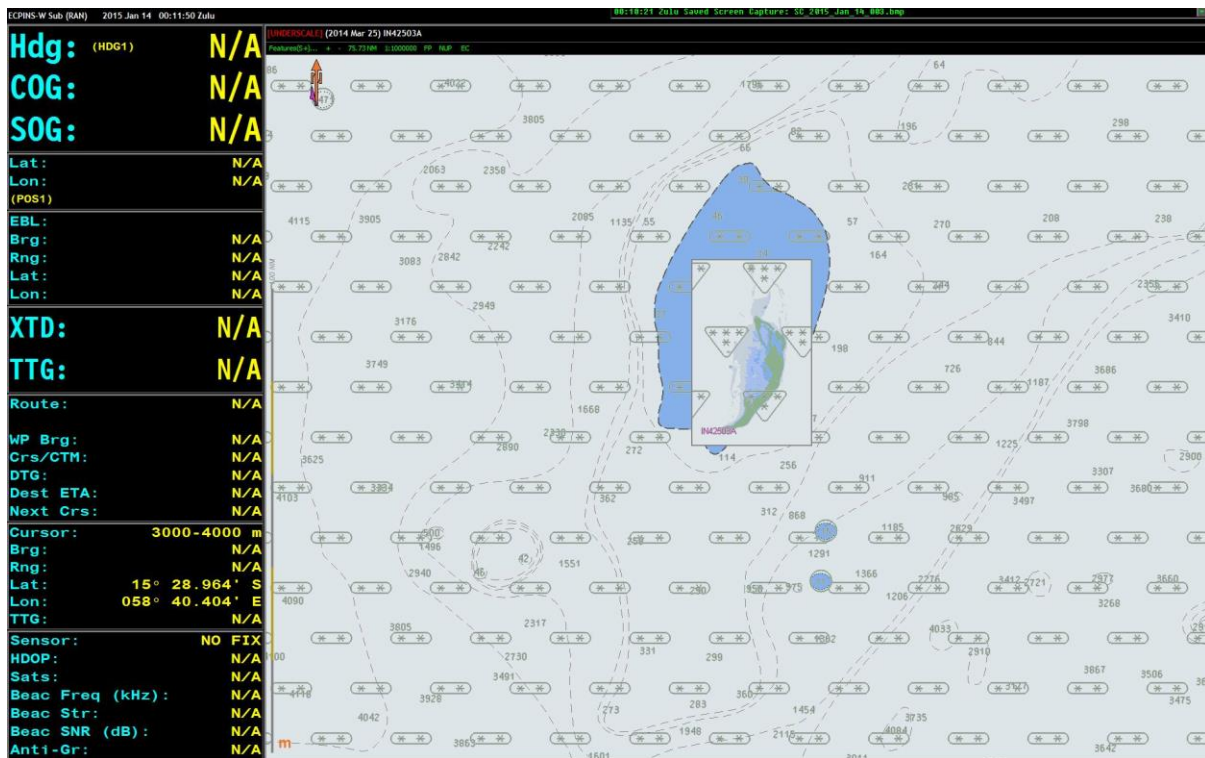
Figure 17 – The ENC data quality feature. An ECDIS screen shot of French ENC FR274880 Zoomed in on Cargados Carajos Shoals – with ZOC switched on displaying 4 stars ZOC B at the reef and 2 stars ZOC D in surrounding ocean
